GTR Lighting Knowledgebase Article: Chevy Colorado / GM Canyon LED DRL Failure Fix

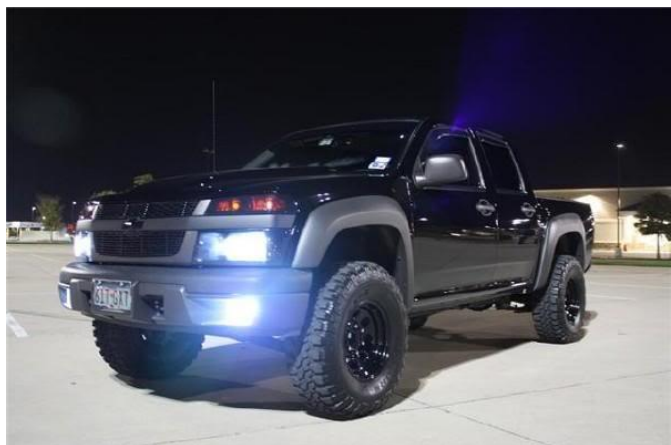
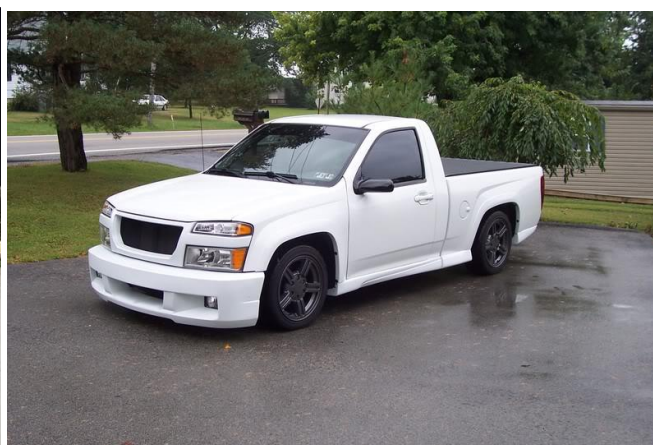
When installing a low-load LED bulb replacement in 2004+ Chevrolet Colorado and GMC Canyon trucks you may run into a problem with the LED burning out or melting.

This happens because when the truck first starts up the alternator (which is controlled by computer) is pushing out more than 14 vdc, maybe 15.5 or 16 vdc. If this happens multiple times over the course of several days the LED daytime running light bulbs can get damaged.

For some reason this problem seems to be limited to the DRL bulb position, and not others like fog lights. What needs to be done is to install a small 100 ohm resistor in line with the positive wire. **DO NOT WIRE IT IN PARALLEL WITH POWER AND GROUND!!**
